**State of Utah**  
**DEPARTMENT OF NATURAL RESOURCES**  
**Division of Oil, Gas & Mining**

**Inspection Report**  
**Minerals Regulatory Program**  
April 20, 2006

**Mine Name:** Parleys Canyon Rock Quarry  
**Operator Name:** Harpers Contracting, Inc.  
4655 West 5415 South  
P.O. Box 18400  
Kearns, Utah 84118

**Permit number:** M/035/012  
**Inspection Date:** April 20, 2006  
**Time:** 9:00 AM

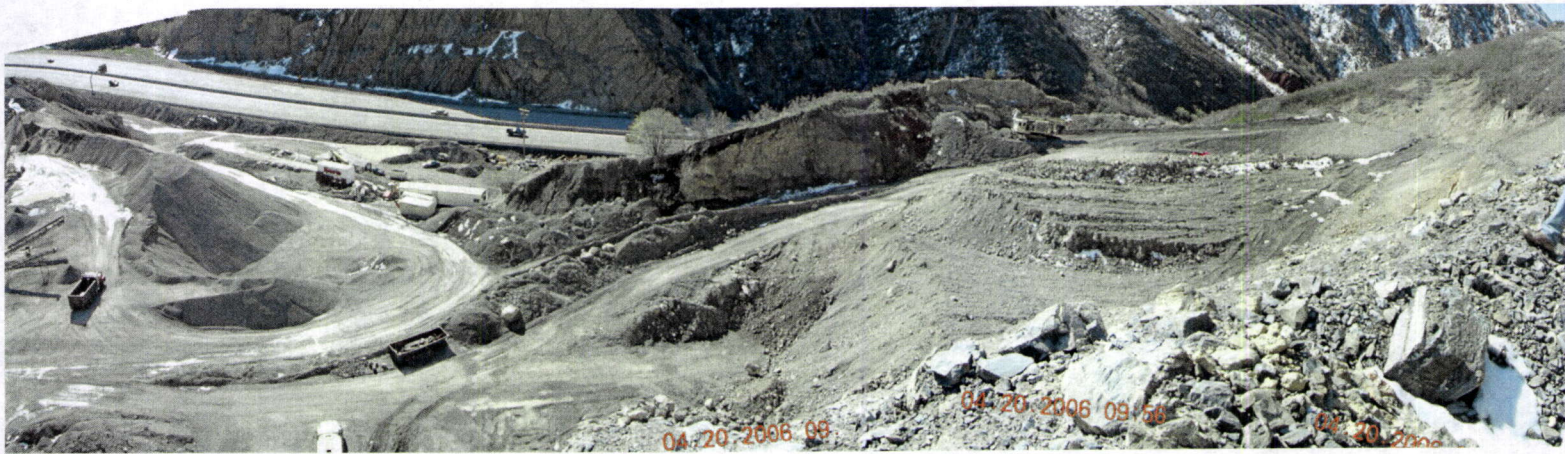
PHOTO 1

The next area visited was an overview of the crusher floor and dozer feed bench from an area west of the active operation. Photos were taken from this area as well (Photos 1 & 2).

OPERATIONS AREA - WEST SIDE

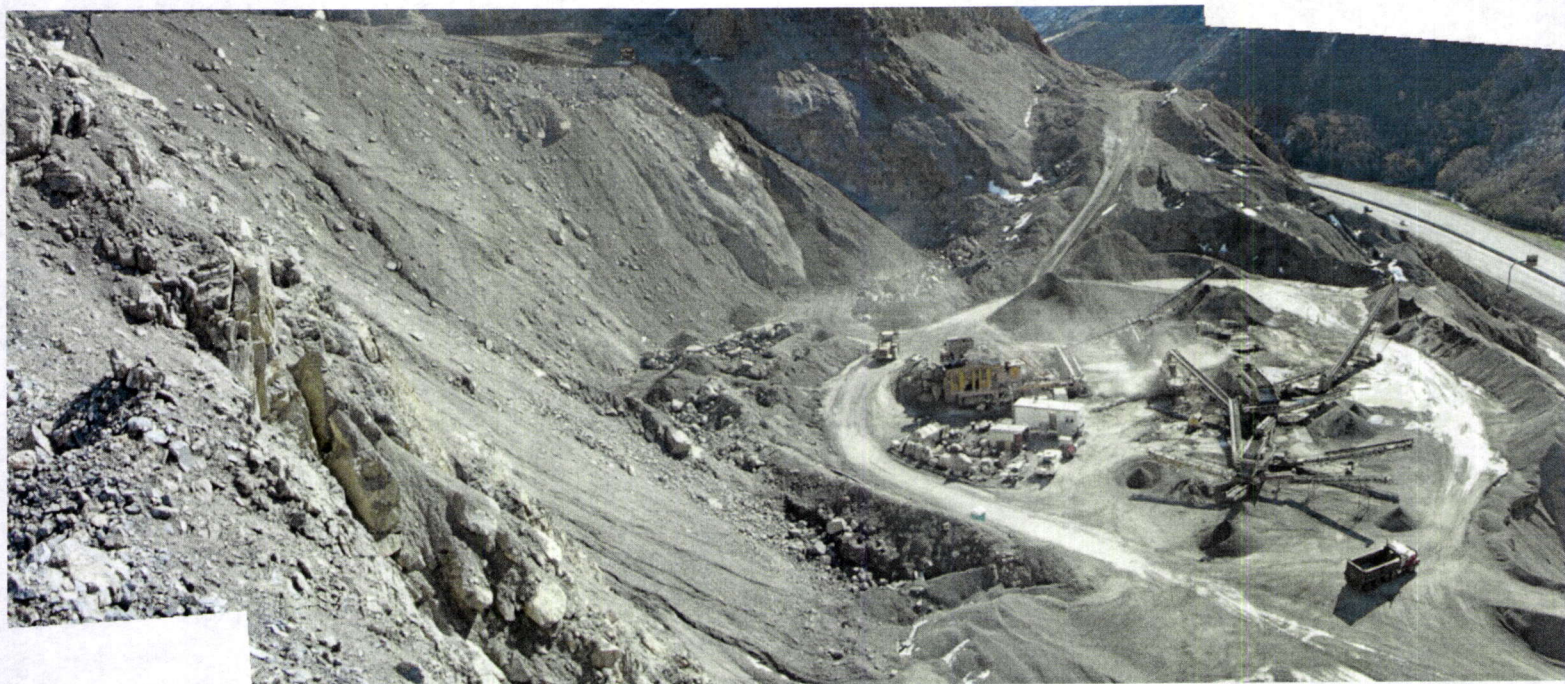
PHOTO 2

OPERATIONS AREA - EAST SIDE

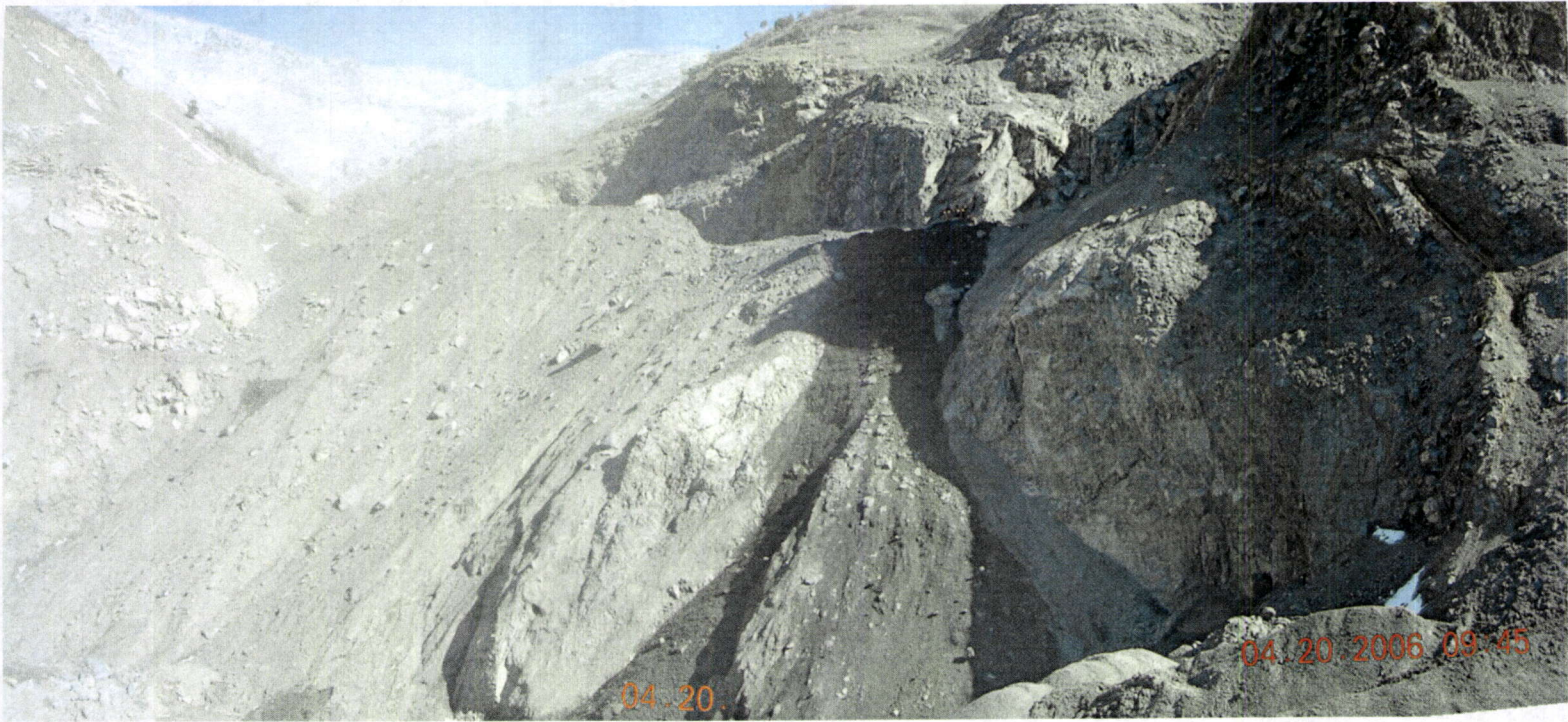
PHOTO 3

The first area inspected was a slot that had been cut above the access road in an area east of the active operation. This slot appears to have been constructed to keep rocks from the site from rolling down onto the road below. The slot runs from the active mine area east around the hill to an area near the Forest Service road. Photos of the operations area were taken from this area. (Photos 3 & 4)

DOZER PUSH BENCH

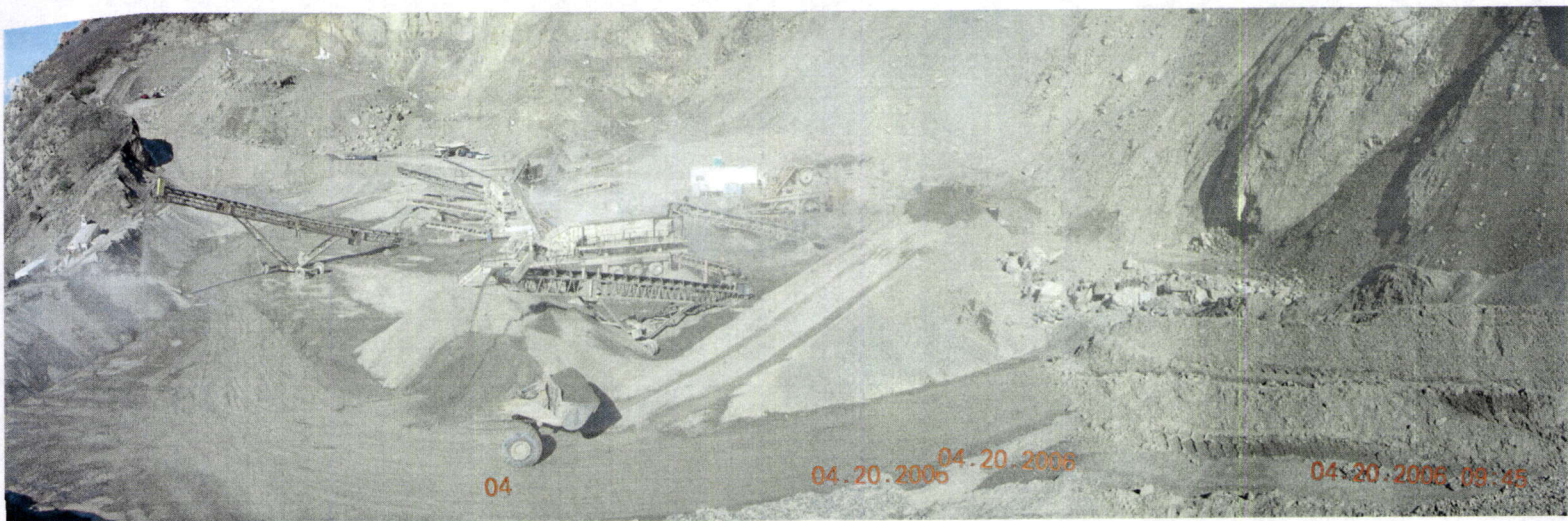
PHOTO 4

OPERATIONS AREA-TAKEN FROM EAST SIDE

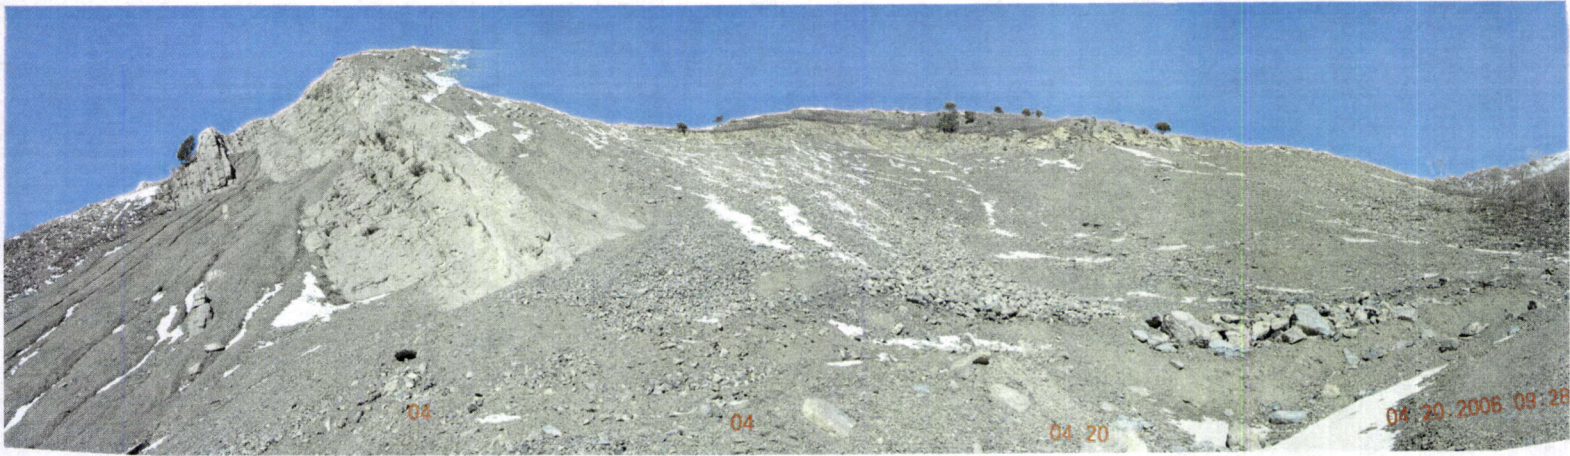
We then left the active mining area and drove east along the access road to the forest service road which accesses the upper portion of the site. There is an area where Harpers have mined a portion of the slope just to the west of the Forest Service road. (Photos 5 & 6) There is a bench half way up the hill where they had pushed material to the area below. This area was inactive and there was no equipment located in this area.

PHOTO 5 INACTIVE EASTERN PORTION OF SIDE

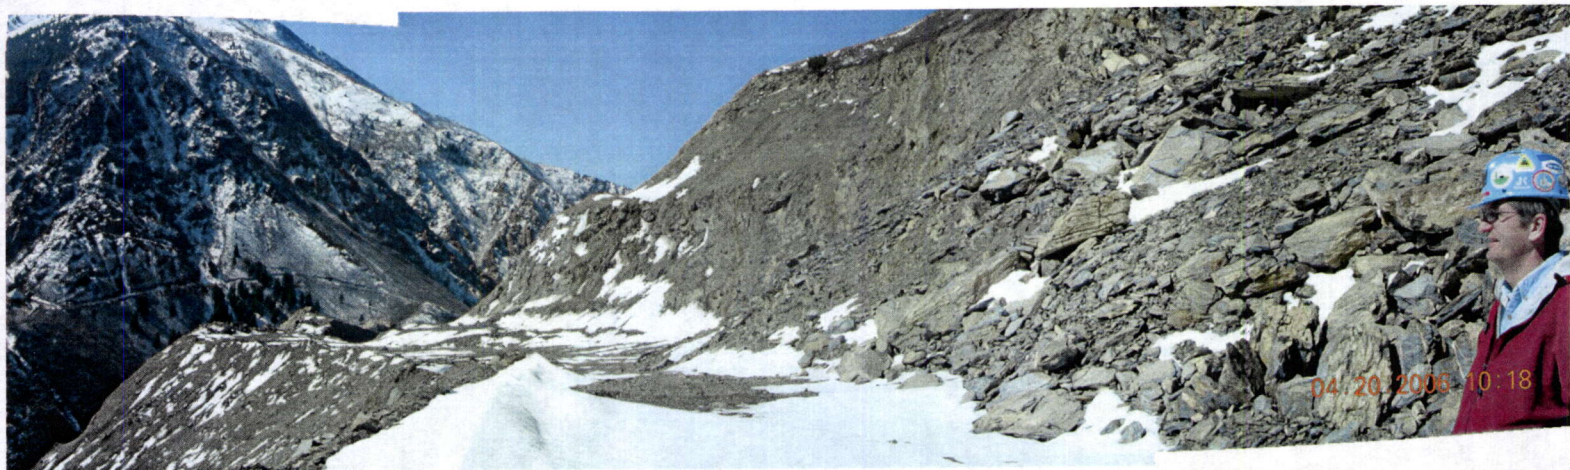
PHOTO 6 AREA ABOVE INACTIVE AREA
